ACA Pen Llŷn a'r Sarnau SAC

Prosiect Morwellt Porthdinllaen Seagrass Project

Vehicular access across the intertidal seagrass bed at Porthdinllaen: review of potential impacts and management options

2017

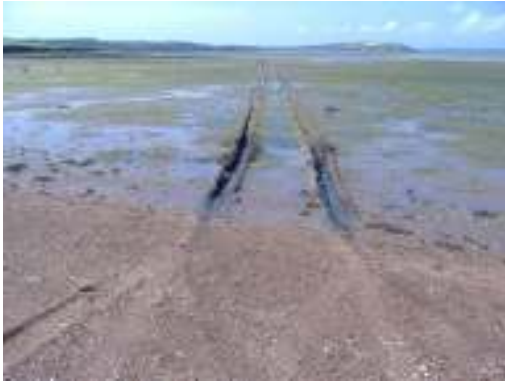
Plate 3.1 Tyre track impact created for the experimental study at Angle Bay (Pauls et al., 2017. Contains Natural Resources Wales information © Natural Resources Wales and database right. All rights reserved).

Over the first 9 months the tyre tracks caused deep ruts and compression of the sediment which led to local changes in hydrology. The ruts were observed to act as small streams channelling water from the surrounding sediments which, in places, washed some seagrass away. After 9 months this water-channelling effect had diminished although the tracks were still visible. Seagrass presence in the impact site took 2 years to recover to a similar level as at the control site, showing a slow recovery time for a single pass event.

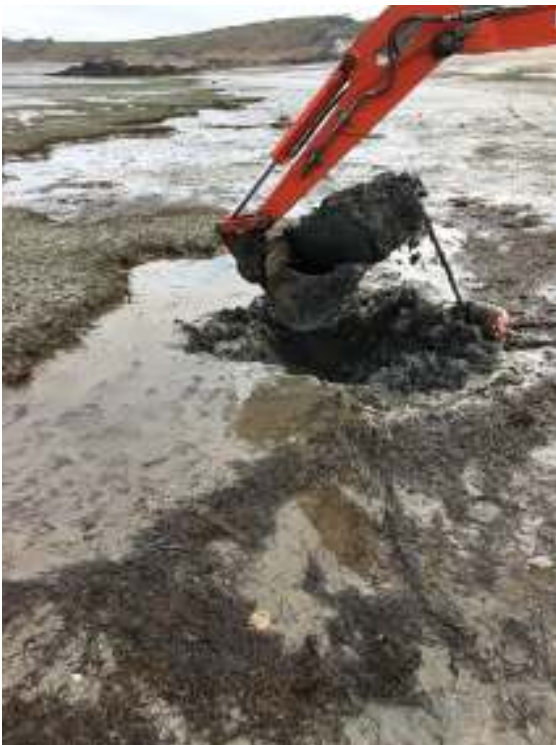
Plate 5.1 Mini digger being used to excavate old intertidal mooring block at Porthdinllaen (© National Trust/Laura Hughes)

The intertidal moorings are inspected at least annually. Access for these inspections and the resulting maintenance has in the past been via vehicle to make the process quicker and carry equipment. Periodically the moorings have to be replaced which requires the use of heavier plant – specifically mini digger and tractor and trailer – in order to extract the old block moorings and replace them with new blocks.

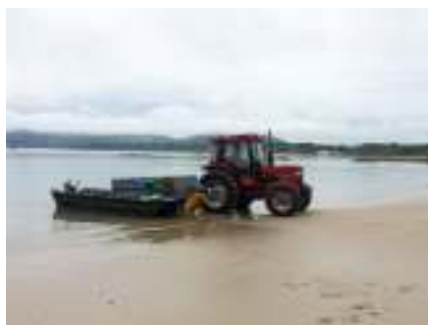
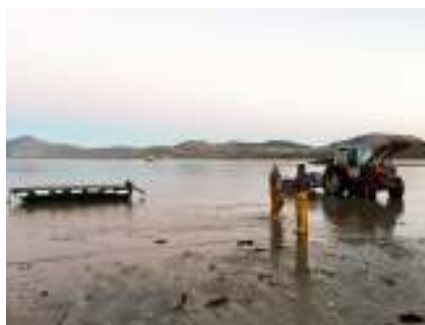
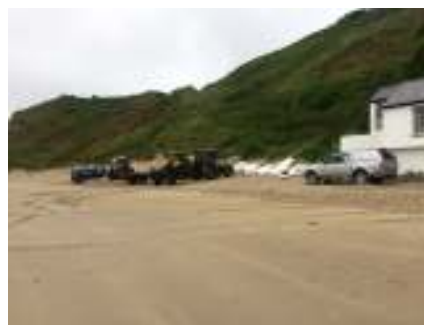
Plate 5.2 (a) & (b) Use of tractors by local fishermen to launch and retrieve tenders and, (c) storage of tractors at the top of the beach at Porthdinllaen (© Gwynedd Council/Catrin Glyn)

The requirement to drive over the seagrass is determined by the tide height when fishermen need access to and from their vessels. At low water fishermen drive around the breakwater wall, and sometimes across the seagrass to access their moored tenders. Driving over the seagrass is seen as an occasional activity, occurring approximately three times a month for each fishing vessel (local fishing vessel owner pers. comm.). This is likely to be more frequent in peak summer fishing season than in winter months. The level of use of vehicles by fishermen at Porthdinllaen is not considered to have changed significantly over recent years.

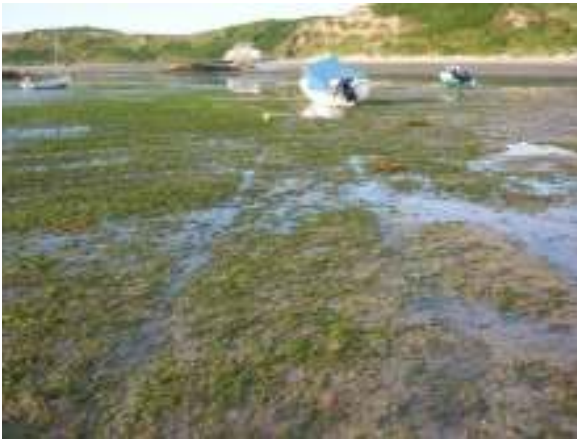
Plate 5.3 Examples of (a) vehicle tracks over the seagrass and, (b) damage caused by mooring chain, recorded during the SAC monitoring in 2004 (Boyes et al., 2008; Contains Natural Resources Wales information © Natural Resources Wales and database right. All rights reserved)

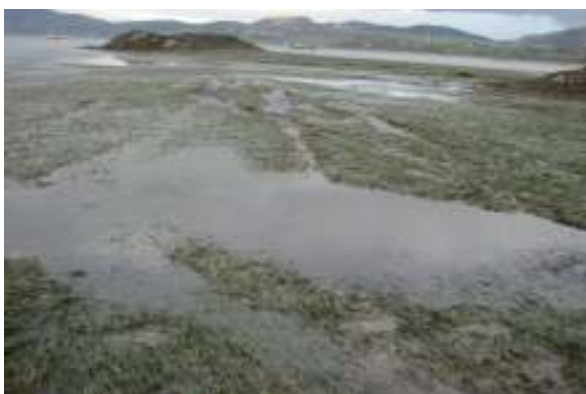
Plate 5.4 Examples of (a) vehicle tracks over the seagrass and, (b) damage caused by mooring chain, recorded during the SAC monitoring in 2016 (Davies et al., 2017; Contains Natural Resources Wales information © Natural Resources Wales and database right. All rights reserved)
